How AAA Helped Royal Melbourne Country Club Create a "Home Away from Home".

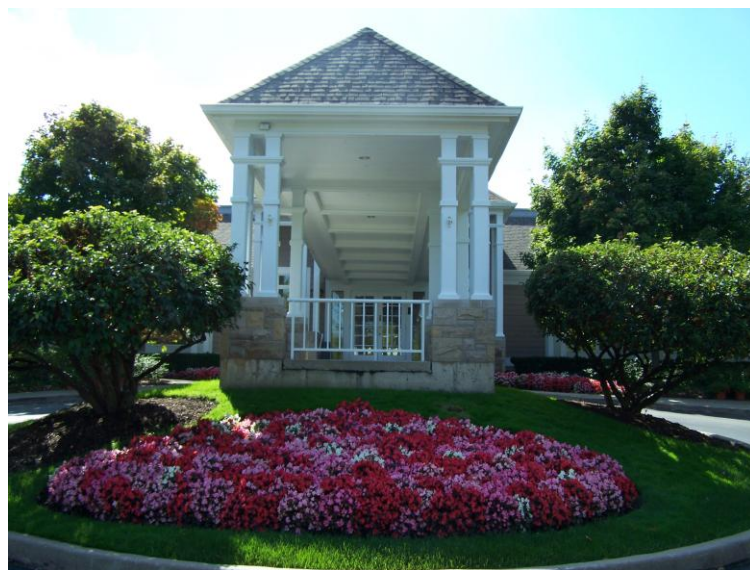
After

AAA was able to repair the damage of the previous contractor and restore Royal Melbourne's clubhouse to its original beauty.

AAA replaced all rotted wood and primed the cedar on all six sides (including cut edges) using long oil primer. Then a granular, polyurethane-based caulk was applied to seal and protect the surfaces. The caulk had a 50% elasticity rating, which helps with expansion cycles in extreme temperature swings.

Surfaces that weren't replaced were power washed with tri-sodium phosphate which is safe for plants, vegetation and animals. Finally, a premium coating was applied to all wood surfaces.

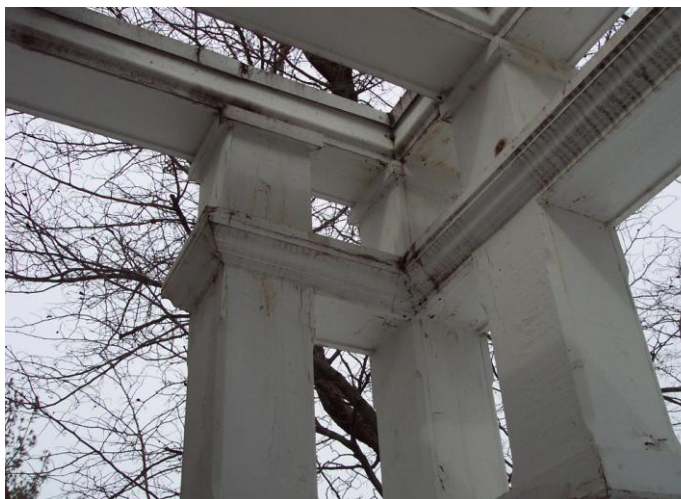
Before

When Royal Melbourne first contacted AAA they were in need of extensive help. Two years prior, the previous club manager had used another contractor who covered partially repaired, rotted wood with inferior paint coatings. The paint began chipping and rotten wood became exposed, causing further decay.
